**MONOPROPELLANT ENGINE INVESTIGATION
FOR SPACE SHUTTLE
REACTION CONTROL SYSTEM**

FINAL REPORT
75-R-460
Volume III

Improvement of Metal Foam for Catalyst Retention

Rocket Research Corporation
Redmond, Washington

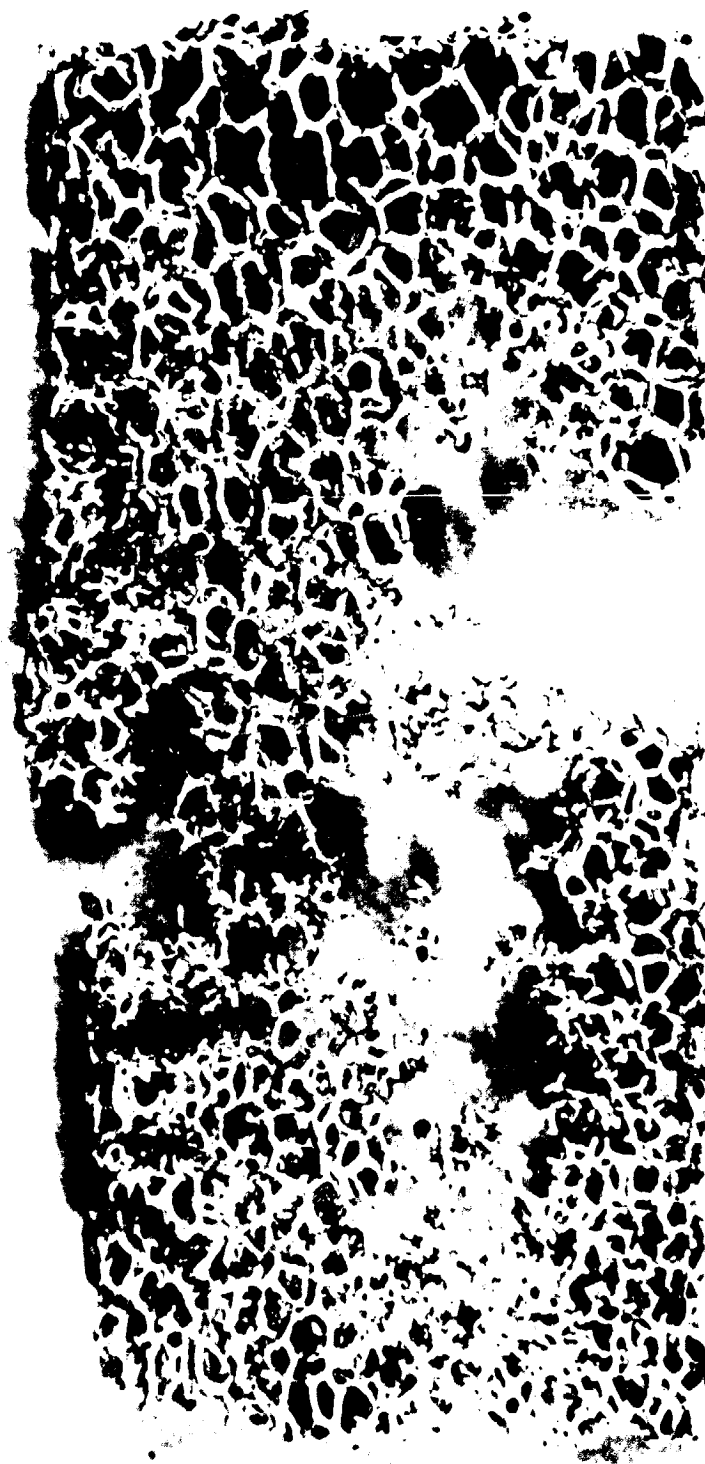
GAS GENERATOR FOAM STRUCTURE, VIEW FROM DOWNSTREAM SIDE

The appearance of a foam hemicylinder removed from the inner bed following the pulse-modulated test is shown in Figure 2-1. Several parts broke off from the foam during the attempt to remove it from the reactor. The foam was very brittle and not as ductile as initially. The half-moon shaped caps at the ends were in good shape, whereas maximum wear had occurred in the center of the sample where it was in contact with the two Rigmesh injector elements.

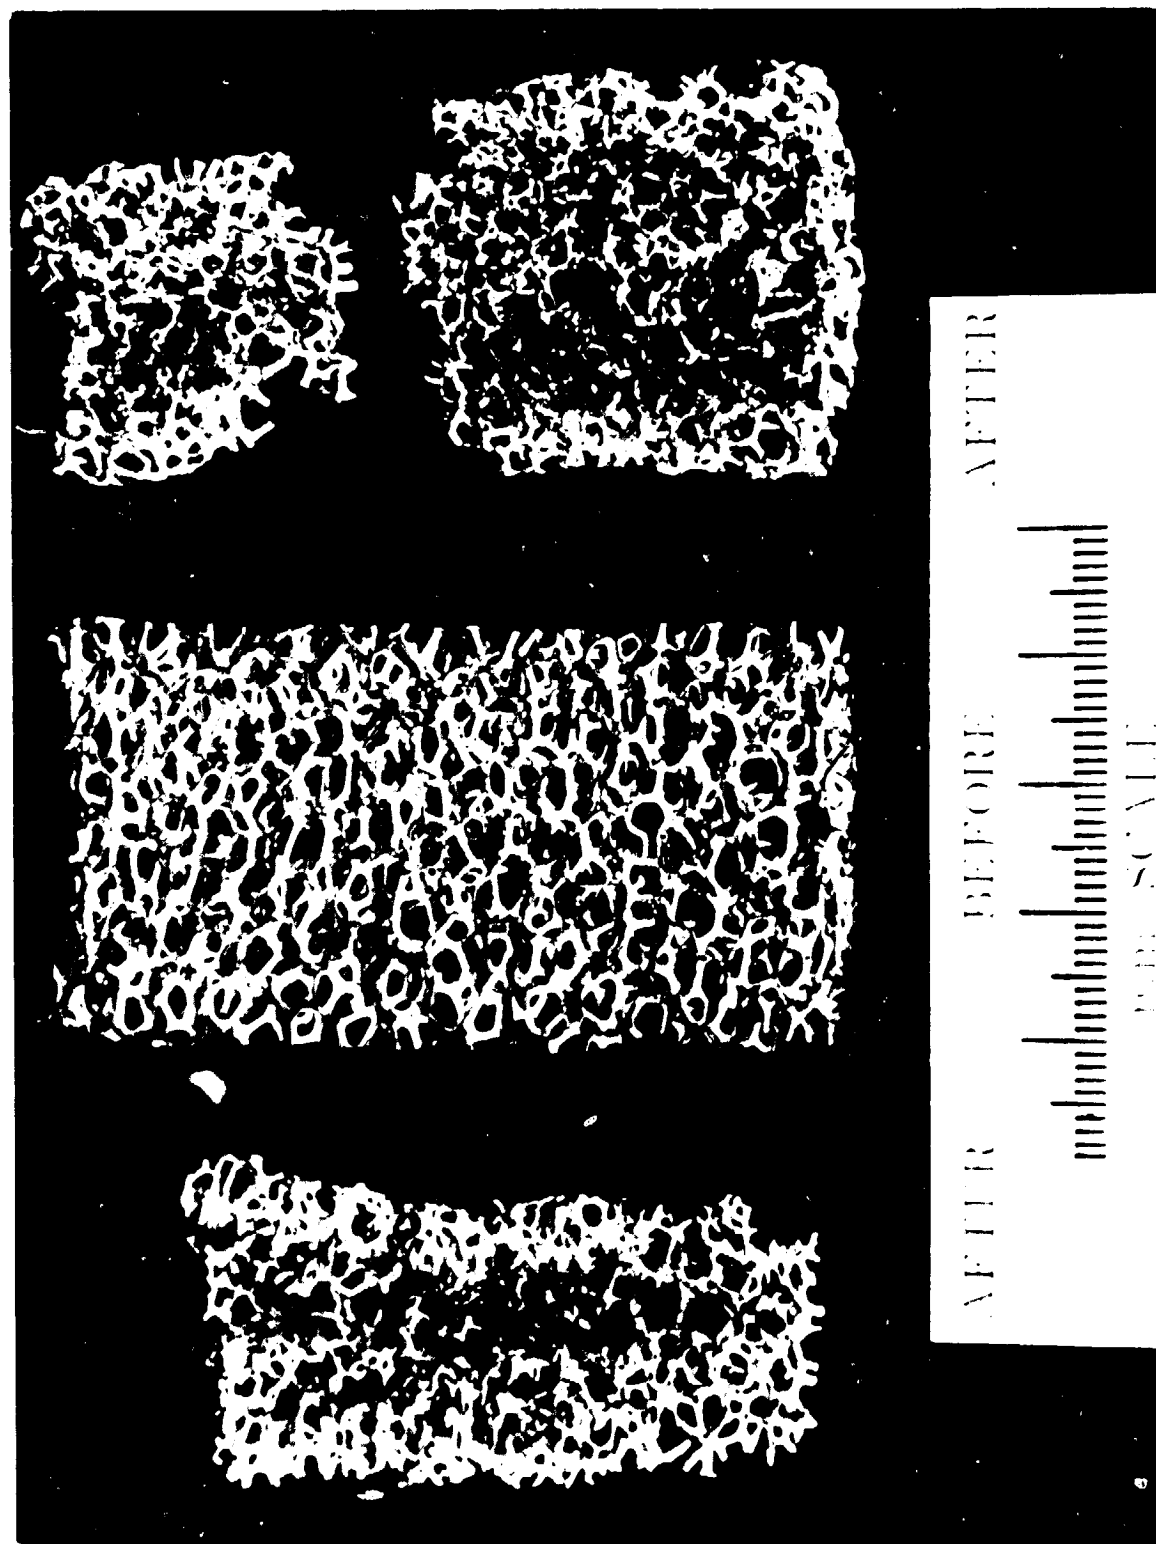
10 PORE/INCH NICKEL FOAM BEFORE AND AFTER TESTING AT NASA-JSC. VIEW FROM INJECTOR SIDE

When inspecting the foam after disassembling the reactor, it was found to be severely worn, in particular in the center portion where it faced the injector elements. A comparison of the 10 pore/inch foam elements before and after firing is shown in Figure 2-2. The foam also was very brittle and had lost its ductility as a result of exposure to the hydrazine reactor environment.

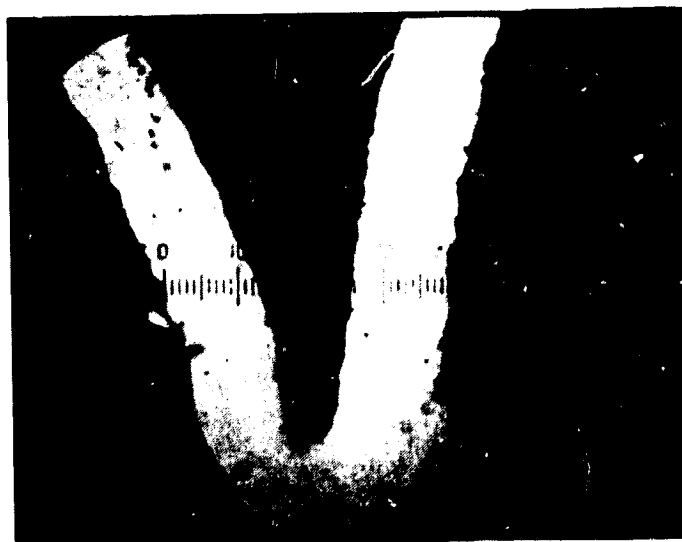
CROSS-SECTION OF
FOAM LIGAMENT IN UNFIRED NICKEL FOAM, 160X, UNETCHED

A cross-section of unfired nickel foam will be shown first. This photo (Figure 2-4) serves as a baseline for comparison of pre- and post-firing foam. In the pre-test condition, the foam has already undergone the burn-out and the annealing treatments, which tend to expel any entrapped electrolyte or gas residues. In spite of this, the electrodeposit which makes up the foam structure is very porous and makes the foam more susceptible to attack by nitriding gases. The porosity of the nickel electrodeposited from an all-chloride bath could possibly be reduced by additives to the plating bath. However, all commercial brightener additives contain sulfur and the deposit is rich in sulfur. Sulfur contamination has to be avoided because it would poison the Shell 405 catalyst.

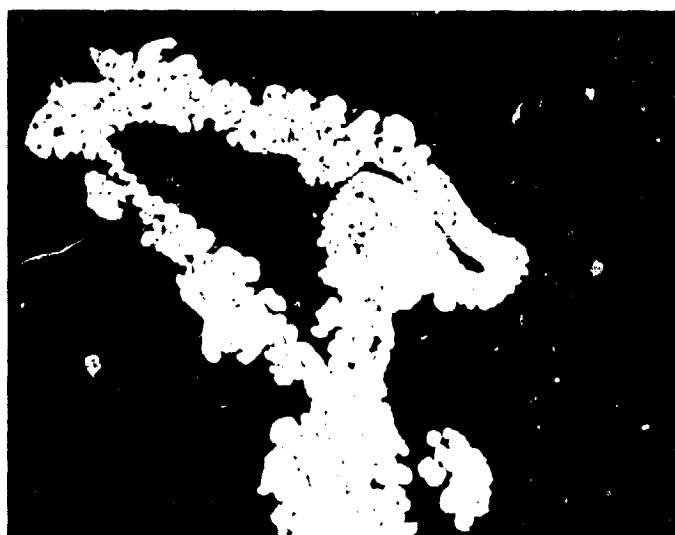
CROSS-SECTION OF FLATTENED LIGAMENT,
POST PULSE-MODULATED TEST,
MAGNIFICATION 40X

A cross-section of an originally triangular ligament is shown in Figure 2-5. This particular ligament has been flattened by external pressure or impact forces. The porosity is comparable to that observed after 8 hours nitriding in ammonia at 2,000°F.

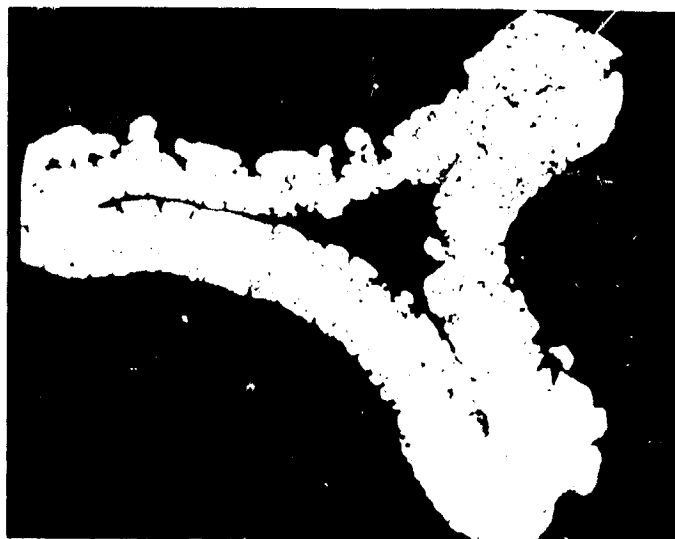
CROSS-SECTION OF FOAM LIGAMENT
FROM NASA-JSC TEST, MAGNIFICATION 40X

10 pore/inch foam are larger and have thicker walls. Figure 2-6 shows the cross-section of a ligament which also has collapsed under external forces, allowing opposite walls to touch inside the hollow ligament. Erosion is more pronounced on the outside than on the inside of the ligament.

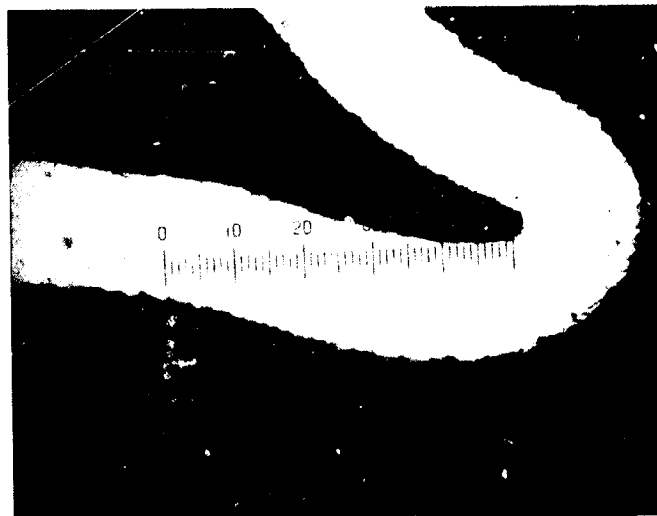
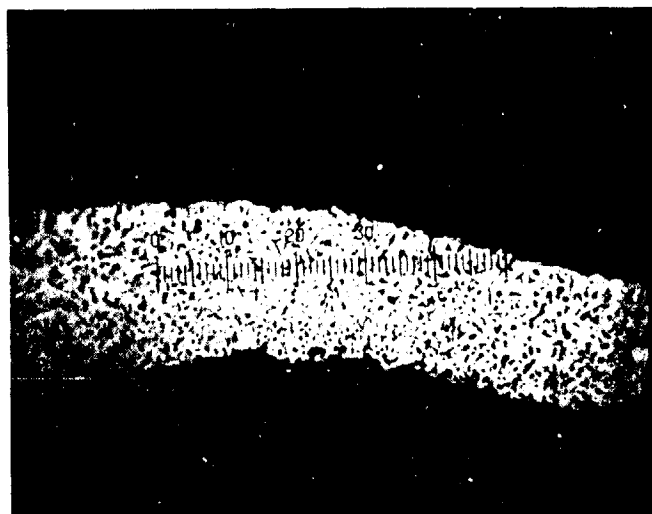
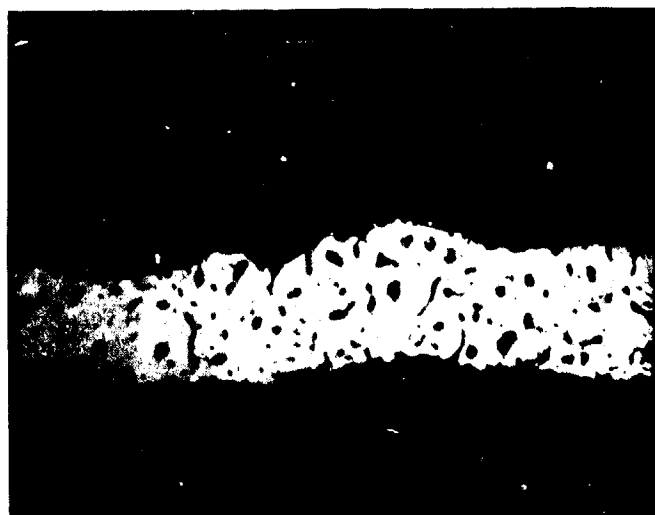
PROGRESSIVE POROSITY FORMATION IN NICKEL FOAM
DUE TO NITRIDATION IN AMMONIA

1 SCALE UNIT 6.25 μm

PRETEST

922°K (1,200°F)

1,144°K (1,600°F)

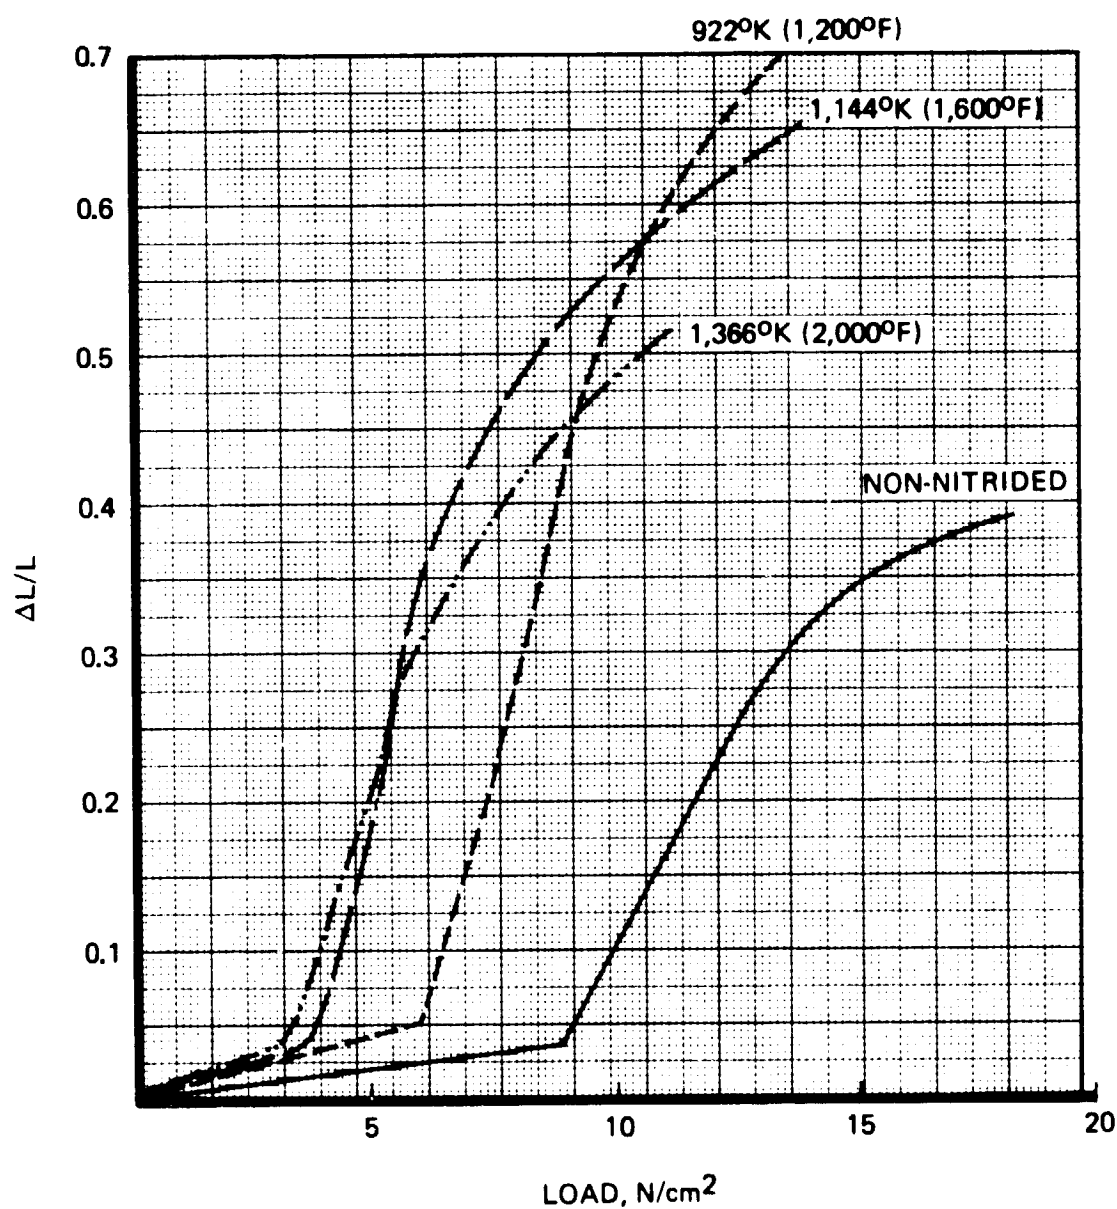
**CRUSH STRENGTH OF NICKEL FOAM
AFTER 100-HOUR NITRIDATION IN AMMONIA**

sample exposed for only 8 hours was just as weak as a sample exposed for 100 hours. The most important point in the crush curves shown in Figure 3-2, and similar ones shown in later paragraphs, is the yield point at which the foam starts to deform. Untreated nickel foam with 3 percent density yields at a load of 6 to 8 N/cm², whereas nitrided nickel foam invariably breaks at lower loads. The shape of the crush curves after the sample has started to break shows much scatter and is of little significance.

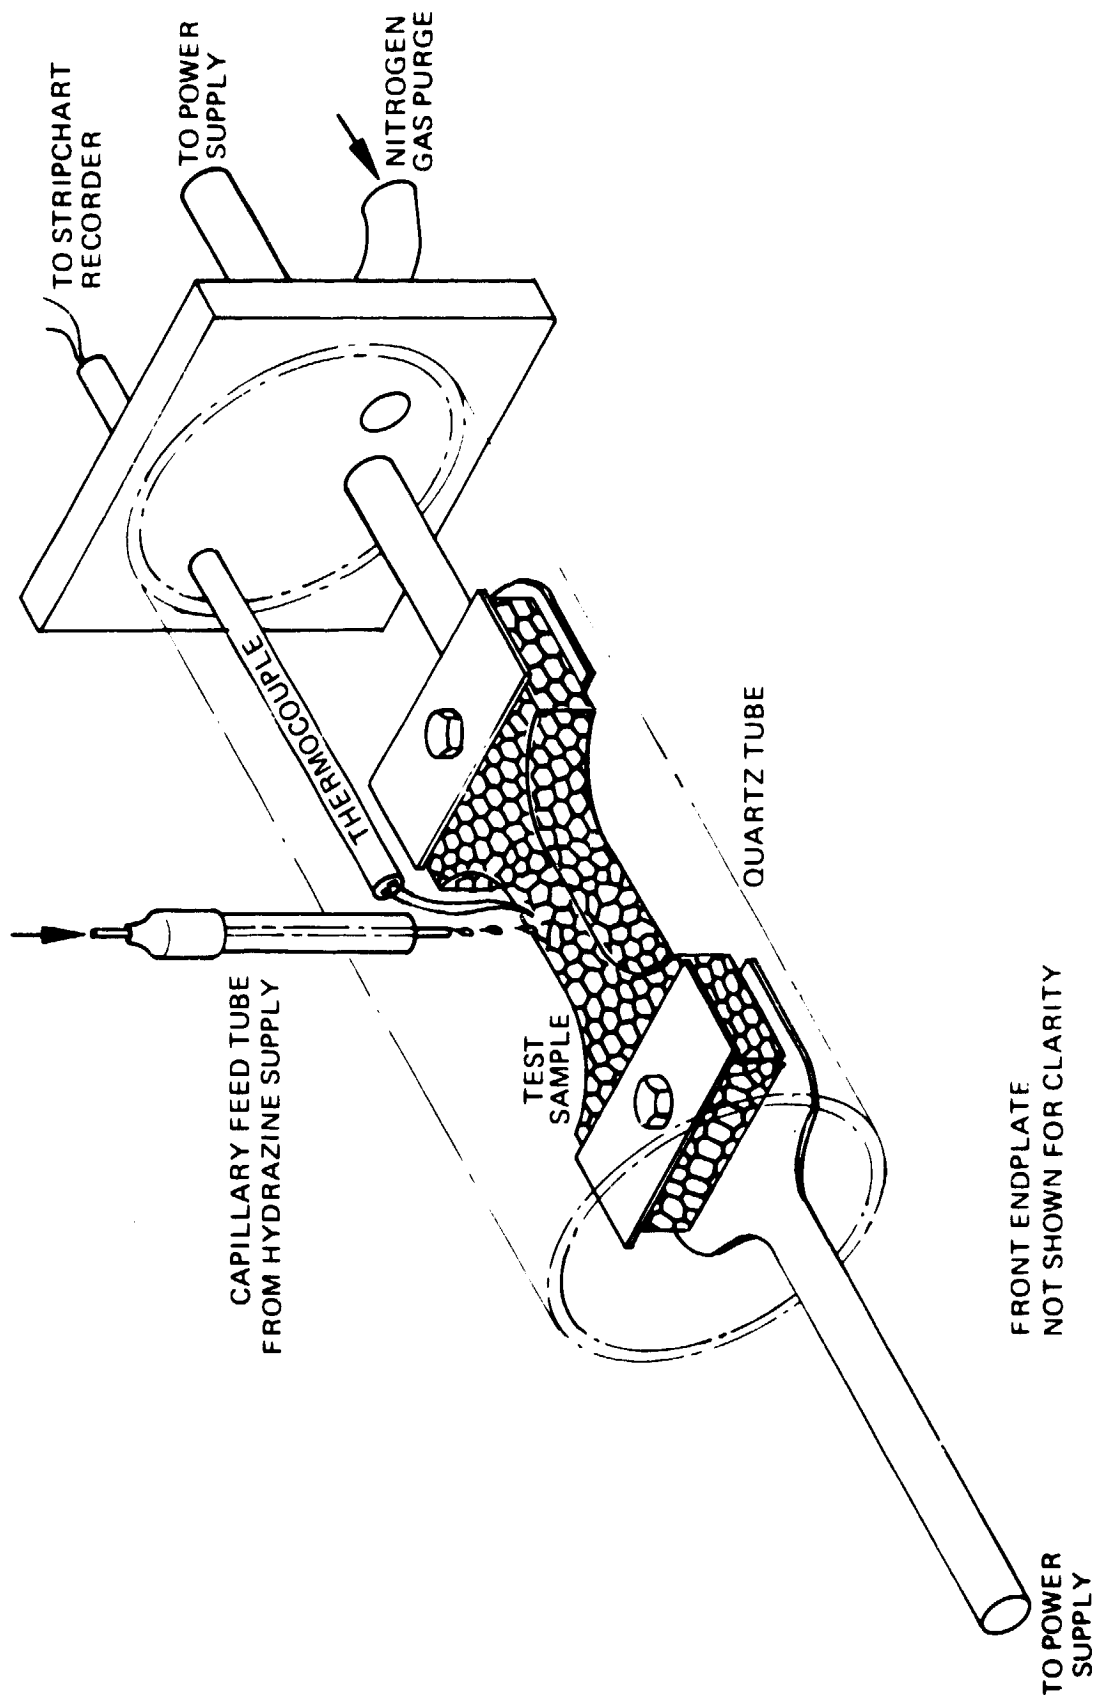
HYDRAZINE NITRIDATION TEST SETUP

A schematic of the test setup is shown in Figure 3-3. The dogbone-shaped sample was cut from a foam slab 10 x 25 x 60 mm. The heated test section had a cross-section of 10 x 10 mm and was 25 mm long. The sample was held between two heavy copper bars which served as conductors. The sample was placed into a 200 mm long, 50 mm diameter quartz tube with two aluminum end plates. The endplates contained gas inlet and outlet adaptors, and thermocouple connections in addition to the power feedthrough. The quartz tube had a narrow (3 mm) side arm through which a quartz capillary hydrazine feed tube could be inserted. The end of the quartz capillary was placed in close proximity to the center of the test sample such that the hydrazine would drop on the sample without premature evaporation. A bare-wire thermocouple was tack-welded onto the sample in the vicinity of the impact point. The hydrazine was fed into the capillary from a pressurized stainless steel cylinder through a quick shut-off ball valve, a 5-micron filter, and a needle valve. The hydrazine tank also carried a sightglass to measure the hydrazine supply and calculate the average flow rate.

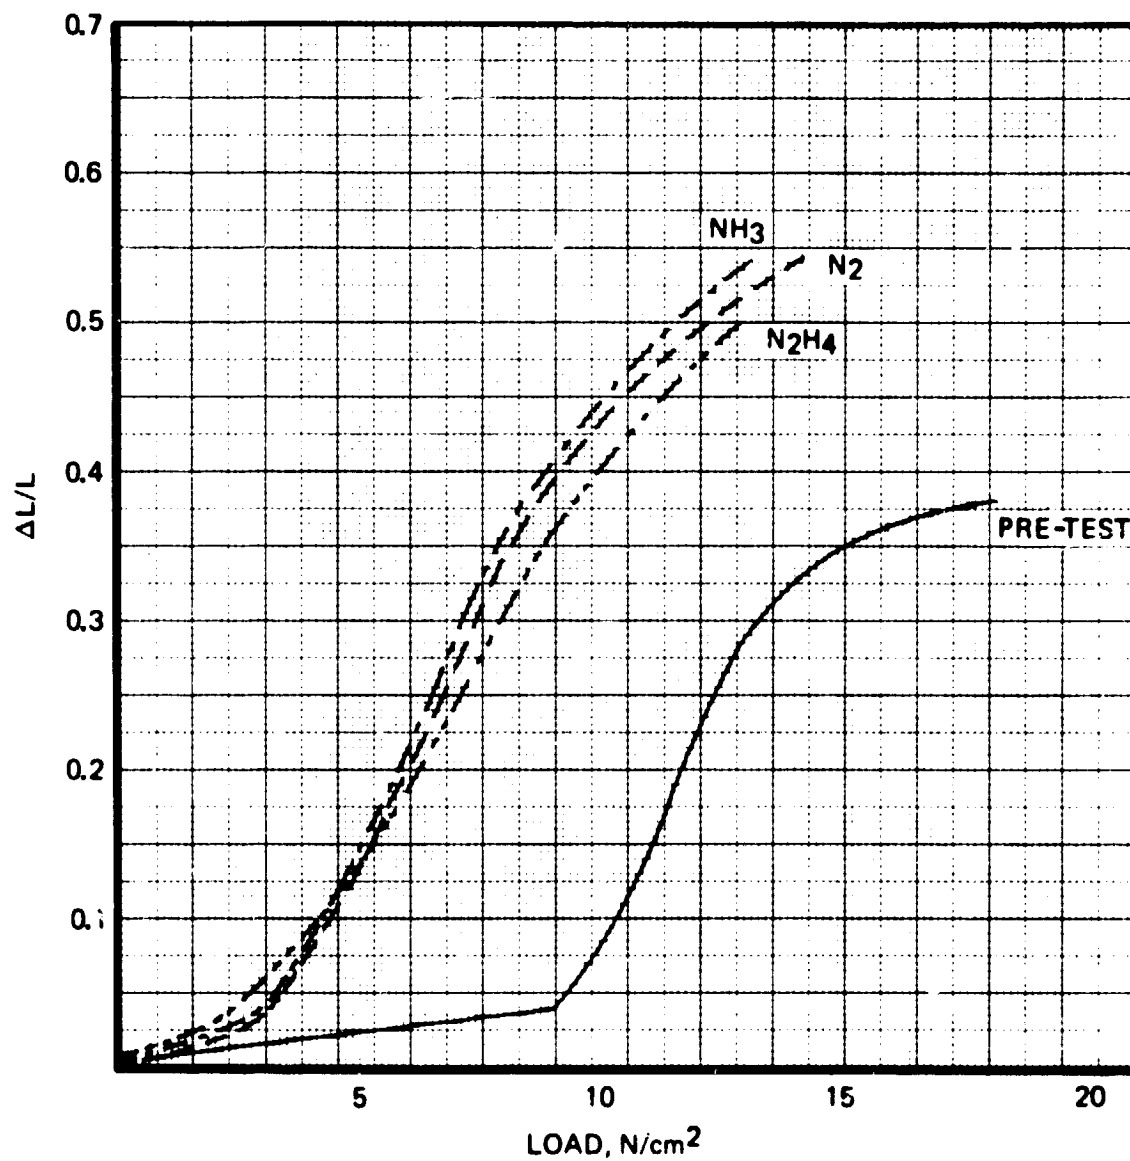
CRUSH STRENGTH OF NICKEL FOAM
BEFORE AND AFTER
8-HOUR TREATMENT AT 1,366°K

The tests were then repeated with ammonia or nitrogen gas flowing instead of hydrazine dripping. The objective of these tests was to answer the question if hydrazine in the state of decomposition is a more active nitriding agent than ammonia or nitrogen. If this was the case, nitriding tests under ammonia would not represent the true conditions in a hydrazine reactor. Based on the results obtained in this test, the damage pattern of hydrazine and ammonia or nitrogen are identical. As shown in Figure 3-4, the yield point of the three samples coincides. In each case, a significant loss of strength is observed when compared to the non-nitrided specimen (solid curve).

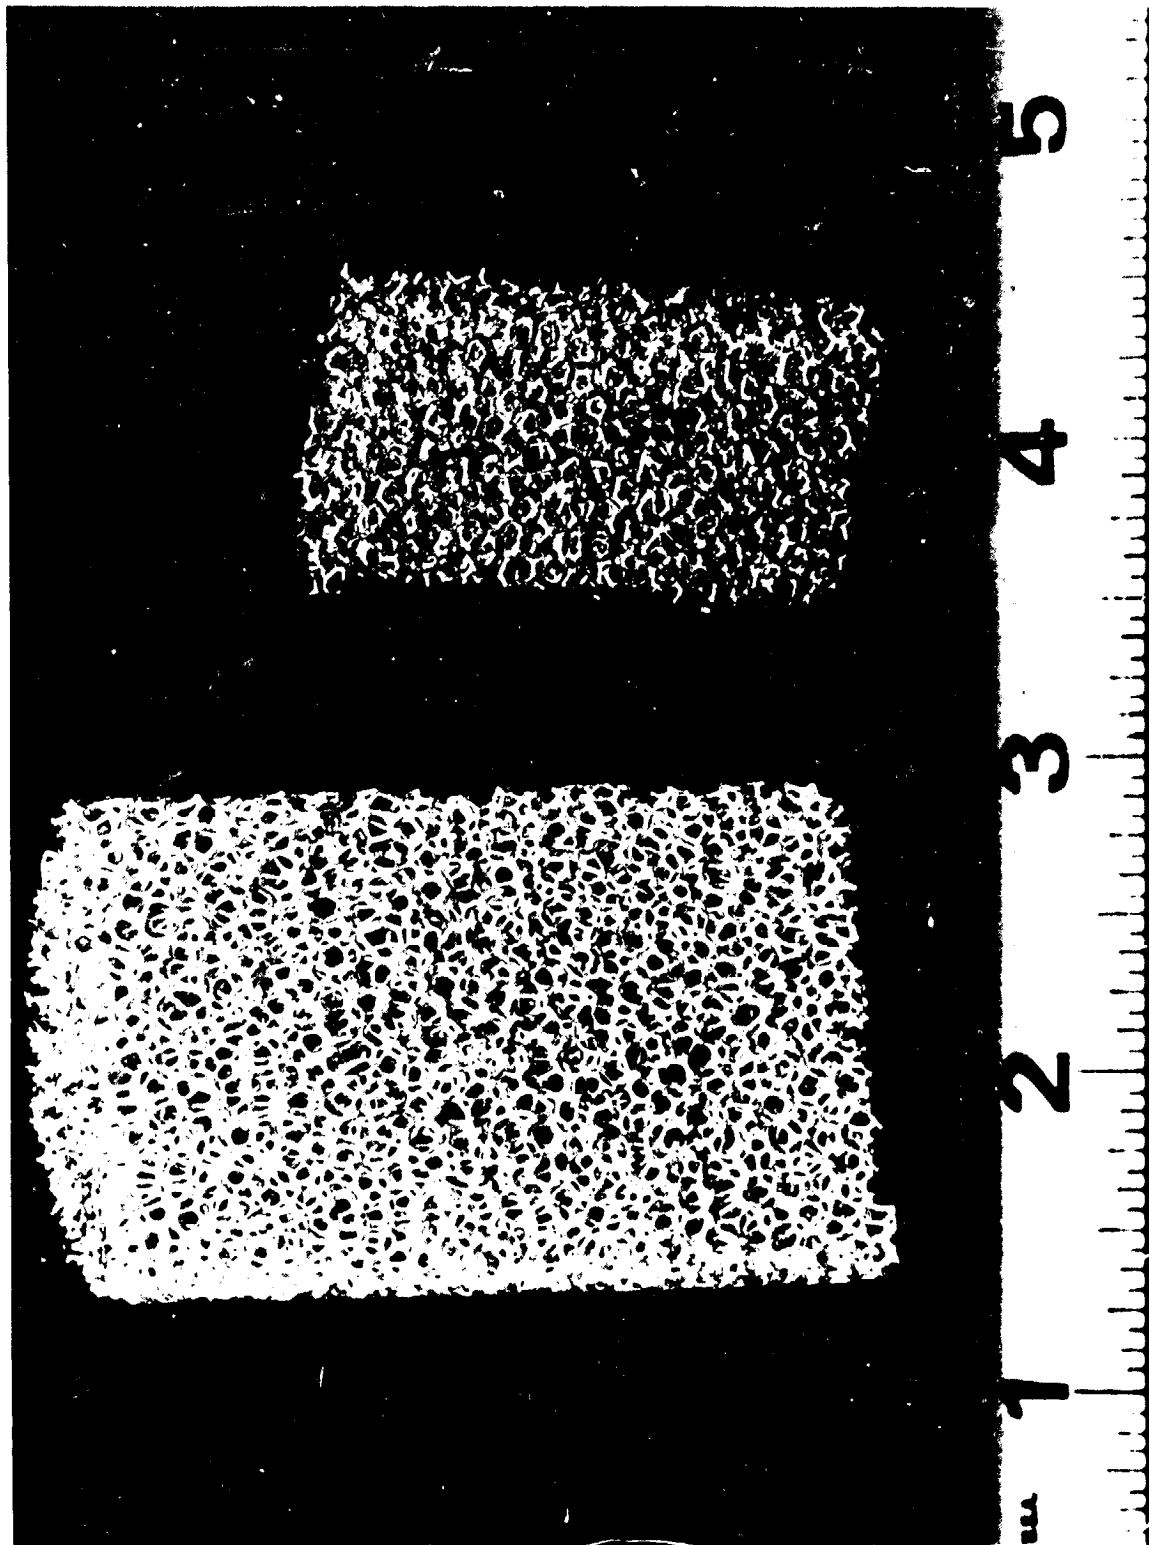
SIZE COMPARISON OF PRODUCTION NICKEL FOAM (LEFT) AND DEVELOPMENT NOBLE METAL FOAM (RIGHT)

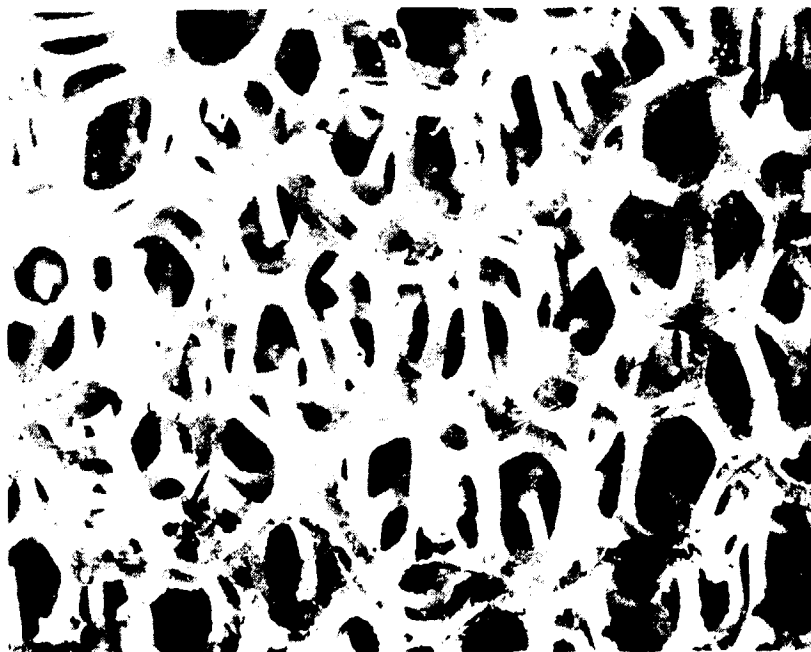
PLATINUM FOAM 003-2-2, MAGNIFICATION 5.3 X

Several attempts to prepare all-platinum foam had to be abandoned at early stages in the process. Early attempts to plate platinum directly on electroless nickel had failed due to corrosion of the thin electroless nickel deposit in the platinum plating bath. The electroless nickel was then replaced by electroless palladium, which is more corrosion resistant than nickel. However, the palladium undercoat peeled away in spite of intermediate gold strikes to relieve stress in the platinum coating (Samples 001-4-3 and 002-5-3). It was suspected that the palladium is responsible for this behavior and that the problem is related to hydrogen saturation of the palladium while it is exposed to the electrolyte as a cathode. For this reason, subsequent tests were conducted with electroless nickel protected by a gold strike. Samples 003-1-5 and 003-2-2 were prepared in this way without the flaking problem observed with the previous samples. Figure 4-2 shows a macrophotograph of the platinum foam sample 003-2-2 after 892 minutes of plating. Total density was achieved only after 1,792 minutes of plating. Toward the end of this period the deposit was no longer as smooth as in Figure 4-2. Instead, the deposit became very coarse and was dull in appearance.

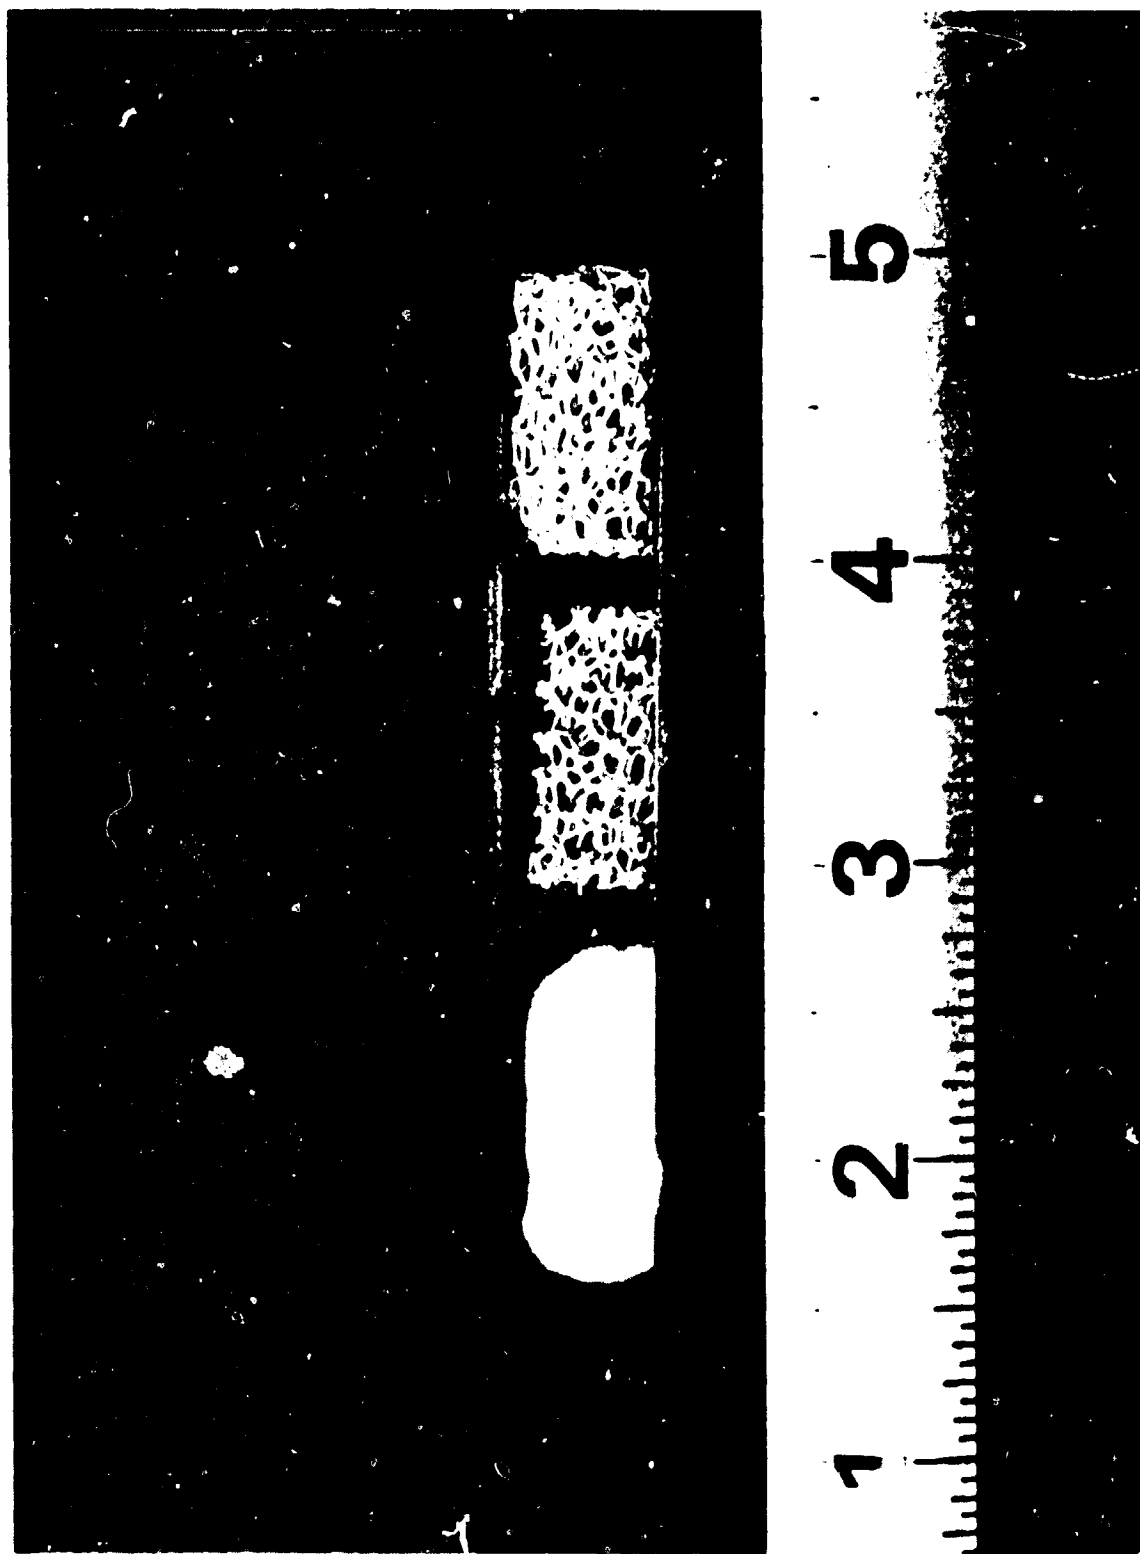
NICKEL FOAM (RIGHT), RHODIUM/NICKEL/RHODIUM FOAM (CENTER) AND REMAINS OF PLATINUM FOAM IN ALUMINA BOAT, FOLLOWING 100-HOUR NITRIDATION TEST 1 INCH SCALE

Post-test inspection of the foam samples contained in the alumina boat revealed that the nickel and rhodium/nickel/rhodium foams remained visually unchanged, whereas the platinum foam had melted and the molten platinum had wicked into the porous surface of the unglazed alumina boat, creating a shiny area (Figure 5-1). The test was then repeated with a new platinum foam sample

from a different lot number; the results were identical to those of the previous test. The test was repeated with platinum foam placed on Shell 405 catalyst in an alumina boat. Again, the platinum melted partially and wicked into the Shell 405 granules.

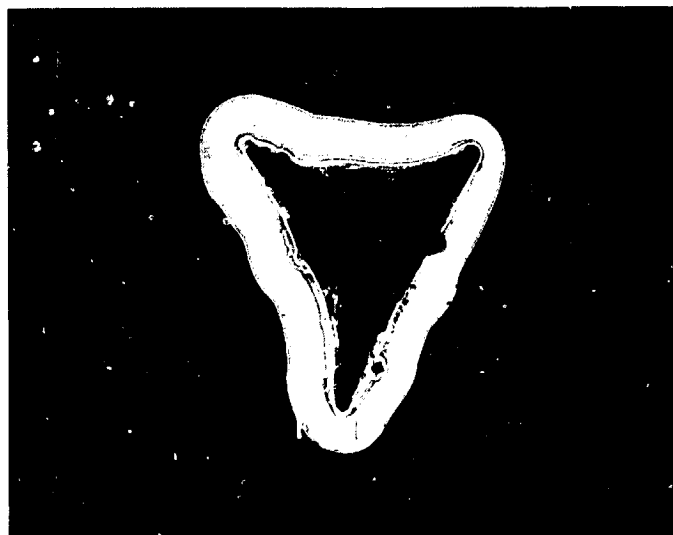
CROSS-SECTION OF
RHODIUM/NICKEL/RHODIUM FOAM, ETCHED, 40X

Figure 5-2 shows the cross-section of a rhodium/nickel/rhodium foam in the as-plated condition prior to burn out. The sample has been polished and etched to reveal the boundaries of the individual layers. The nickel assumed a granular structure, whereas the rhodium remained shiny. The shiny, more reflective rhodium layers on the inside and the outside of the ligament walls are clearly visible. Measurements with higher magnification indicated that the ligament wall is coated with approximately 160 μ m (400 μ inch) rhodium on either side. This rhodium deposit is significantly thicker than rhodium coatings commonly applied for decorative or protective purposes, such as on switches or relays. This explains why adherence problems and stress buildup problems are encountered when electroforming parts by electrodeposition from a rhodium plating bath which is designed for much thinner deposits.

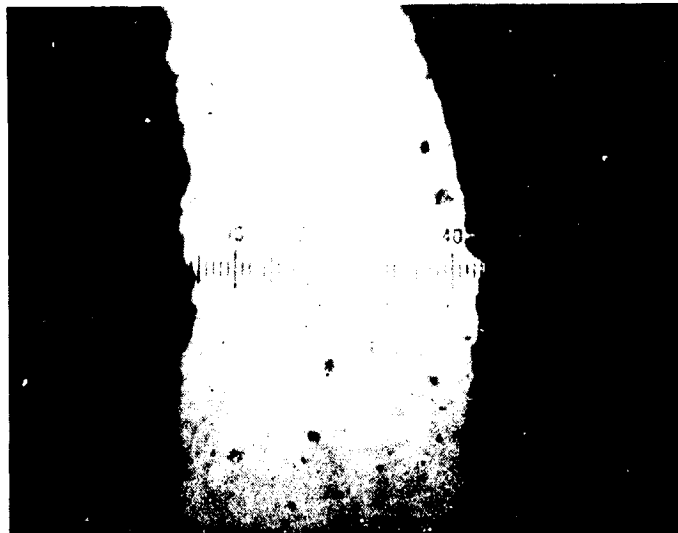
Figure 5-3
RHODIUM/NICKEL/RHODIUM FOAM
AFTER 100-HOURS NITRIDATION IN AMMONIA
AT 1,366°K. 160X, UNETCHED

Figure 5-3 shows a rhodium/nickel/rhodium foam after 100 hours nitriding in ammonia at 1,366°K. Comparing this photomicrograph to that of bare nickel, Figure 5-4, it is obvious that less changes have occurred in the improved foam than in the bare nickel foam. The bare nickel foam shows large voids which are larger than those shown in Figure 3-1C. It must be assumed that this void/porosity formation is one of the causes for the loss of crush strength. Etched specimens revealed excessive nitridation along the grain boundaries. The etching of the specimen in Figure 5-3 did not reveal a nickel/rhodium boundary as shown in Figure 5-2. Apparently the rhodium and nickel had diffused into each other because they form solid solutions over the entire range of compositions.

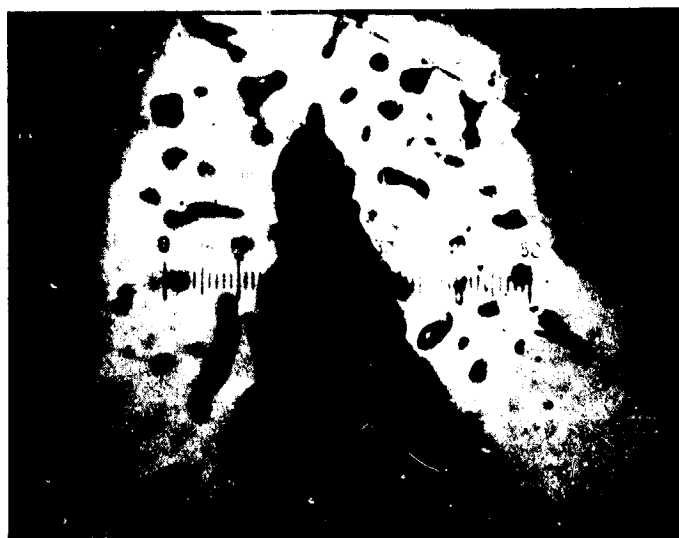
Figure 5-4
BARE NICKEL FOAM
AFTER 100-HOURS NITRIDATION IN AMMONIA
AT 1,366°K. 160X, UNETCHED

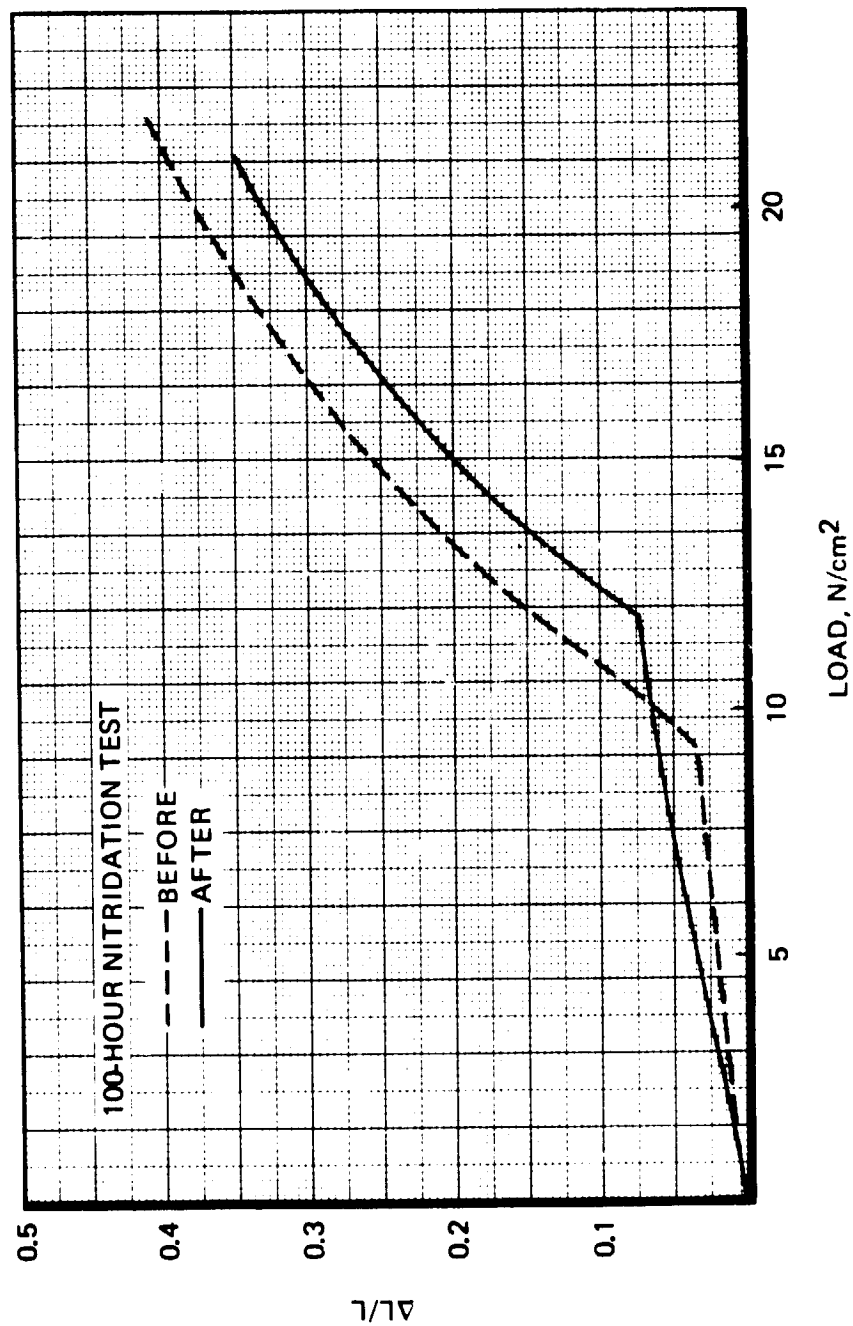
CRUSH STRENGTH OF RHODIUM-NICKEL-RHODIUM FOAM (002-4-1)
BEFORE AND AFTER NITRIDATION TEST

It is suspected that some of the sample-to-sample variation of crush strength is caused by the anisotropy of the original open-cell foam. The foam cells are not truly spherical (dodecahedral), but ellipsoidal. The crush strength is expected to differ depending on the direction in which the load is applied. The orientation of the cells was not always recorded when crush tests were performed. However, the tests were of sufficient repeatability to demonstrate that the rhodium-nickel foam had higher crush strength than the bare nickel foam.
